Contract Report ITL-92-5  
December 1992

# Engineering Reliability of Navigation Structures, Supplement No. 1

*by Thomas F. Wolff, Weijun Wang, Michigan State University*

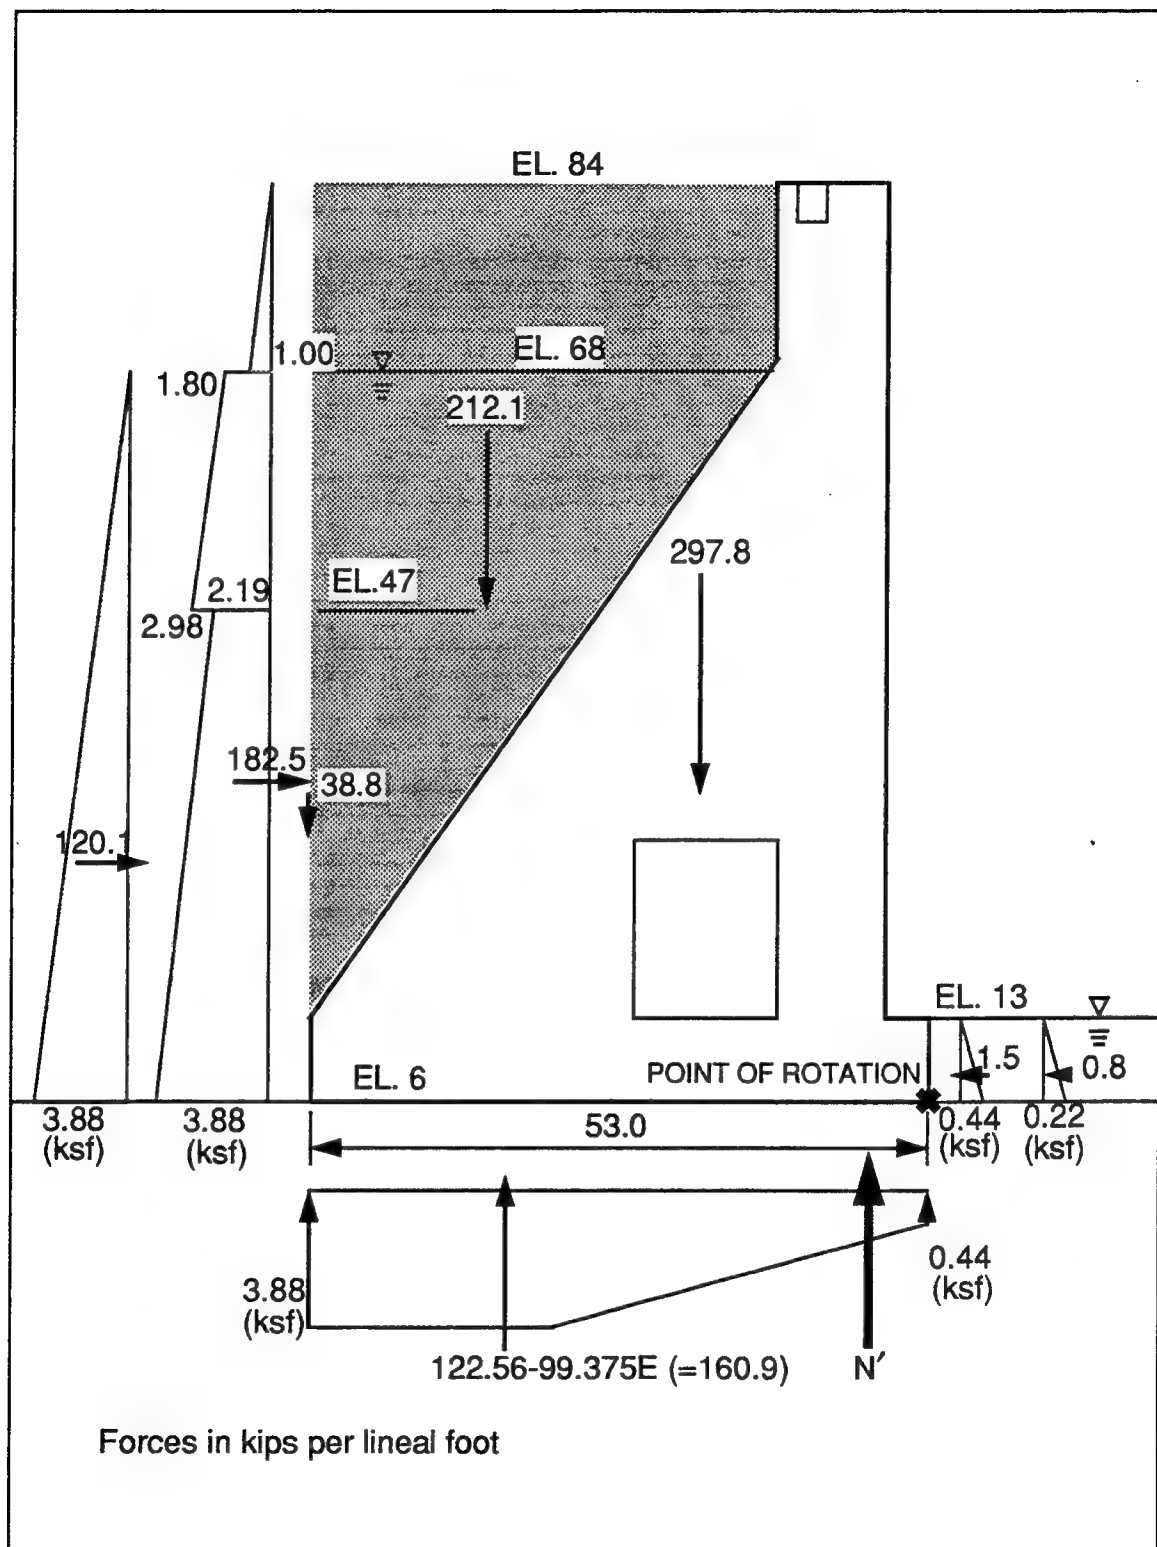
**Figure 7.1 Demopolis Locks and Dam, Monolith L-17, Resultant  
Location Analysis, Free Body Diagram**

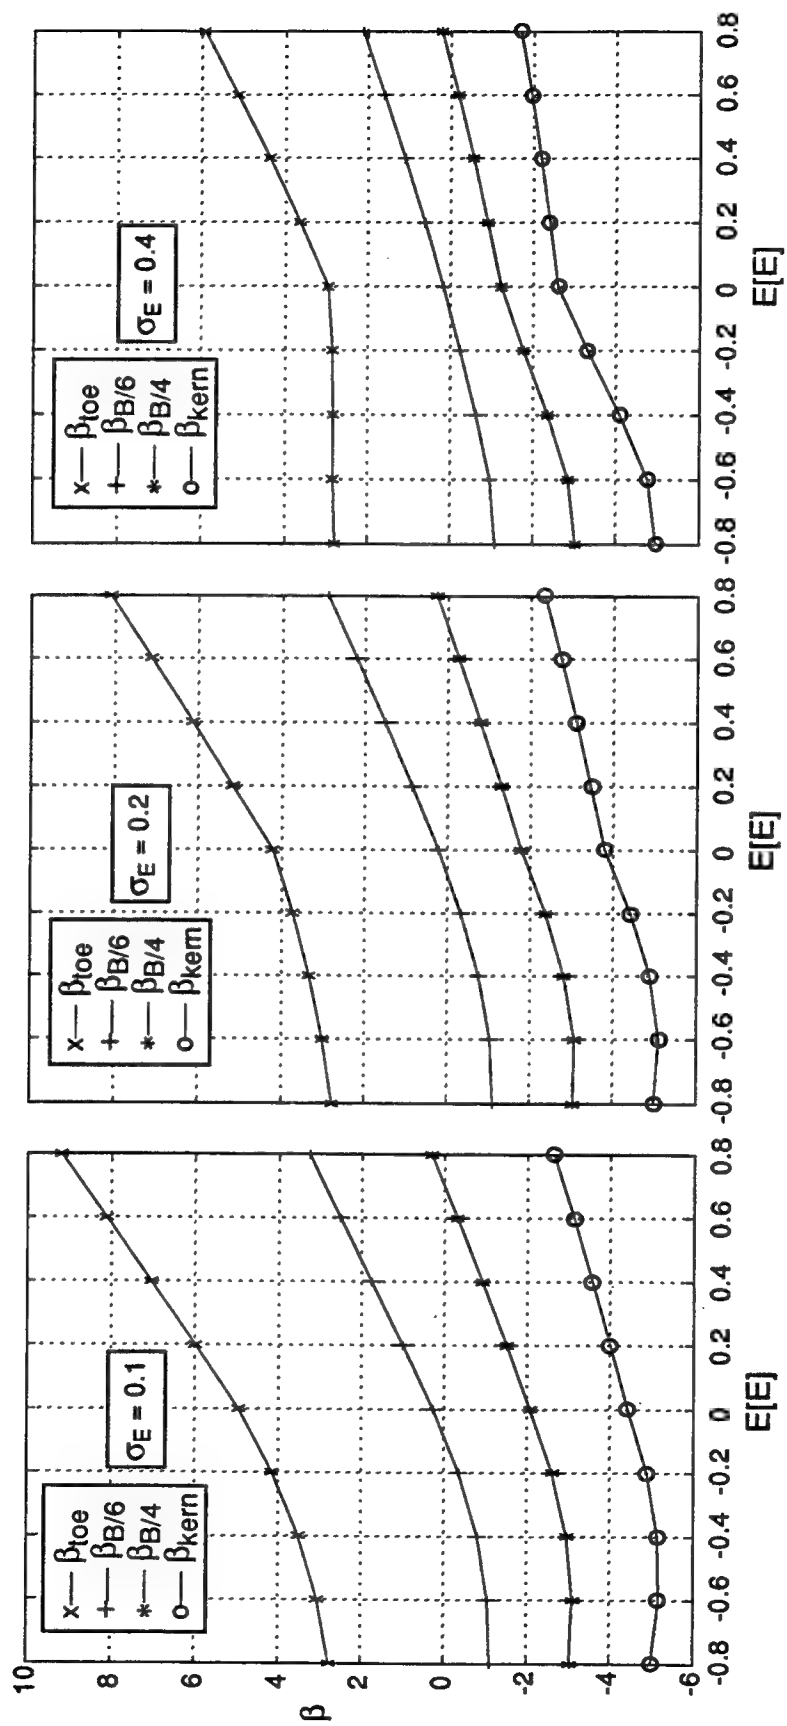
Figure 7.2 Demopolis Locks and Dam, Monolith L-17, Resultant Location Analysis  
 $\beta$  versus  $E[E]$  with  $\sigma_E = 0.1, 0.2$  and  $0.4$

**Effects of Uplift Parameter  $E$  on Reliability Index.** Figures 7.2 through 7.5 summarize the results of parametric studies to assess the effect of the expected value and standard deviation of the uplift parameter  $E$  on reliability indices. Figure 7.2 shows trends very similar to those shown in Figure 2.4 for monolith M-16 at Lock and Dam No. 2; the reliability increases with increasing  $E[E]$  and decreases with increasing  $\sigma_E$ . Likewise, Figure 7.3 shows trends very similar to those in Figure 2.5. The major difference from Demopolis to Lock and Dam No. 2 is that the reliability indices for the Demopolis monolith are much lower and are somewhat less sensitive to  $\sigma_E$ . It should be recalled that these values may be lower than "actual" due to the large variance assumed for the backfill water level, however it is clear that both  $E[E]$  and  $\sigma_E$  are significant random variables which must be considered in analysis. Figures 7.4 and 7.5 combine the information for  $\beta_{\text{toe}}$  in the previous two figures on a single graph for comparison; again, it is noted that  $\beta$  may tend to a minimum near  $E[E] = 0$  when  $\sigma_E$  is large.

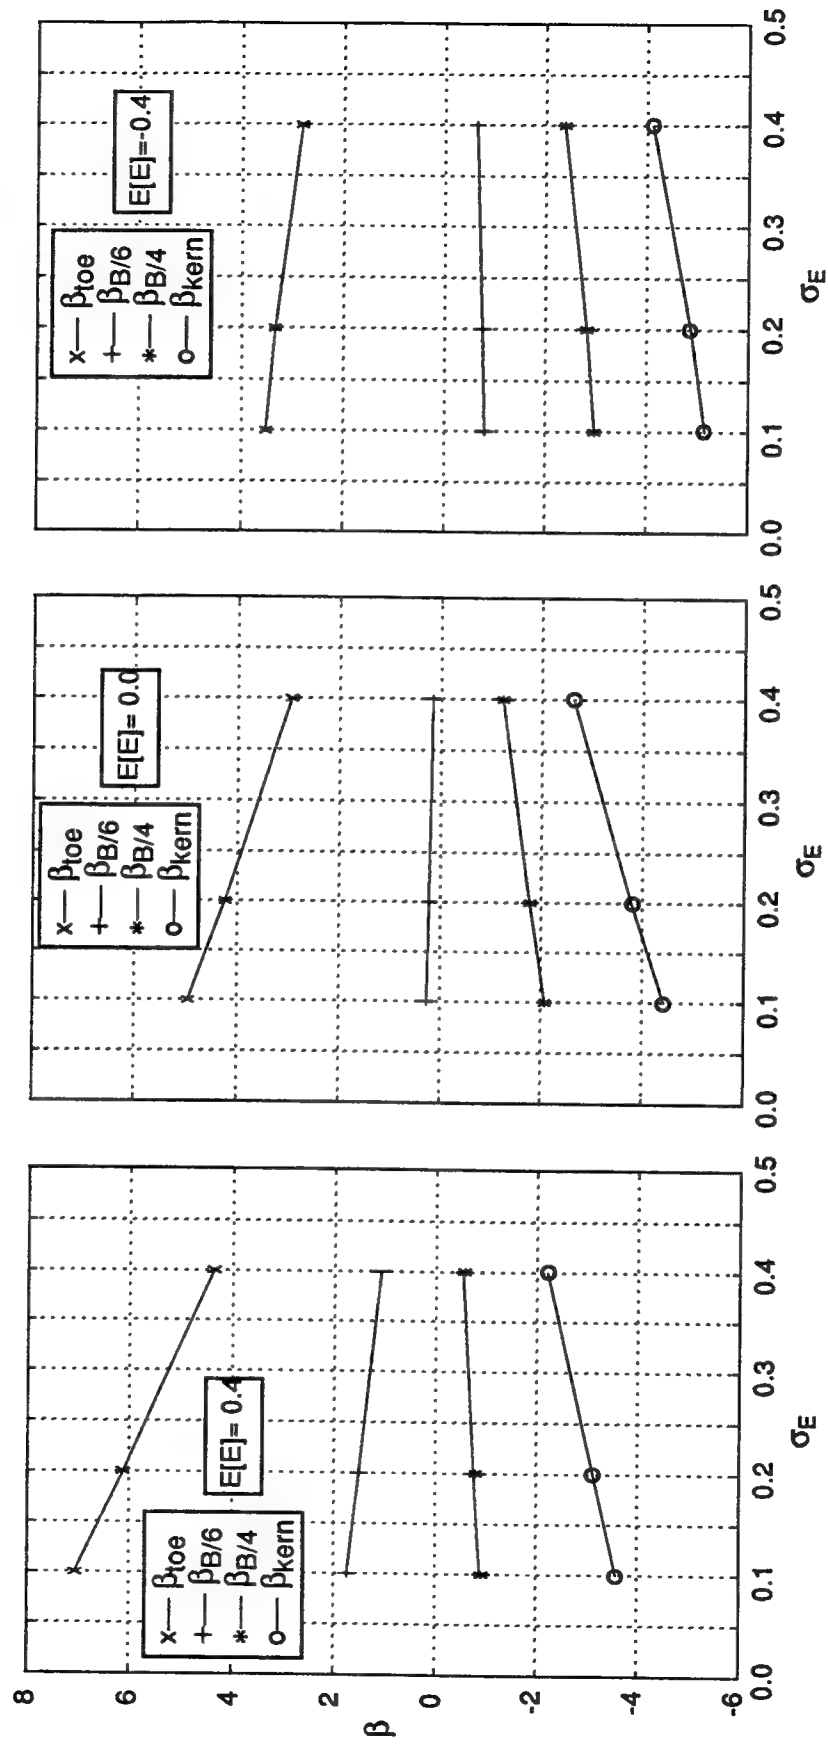
Figure 7.3 Demopolis Locks and Dam, Monolith L-17, Resultant Location Analysis  
 $\beta$  versus  $\sigma_E$  with  $E[E] = 0.4, 0.0$  and  $-0.4$

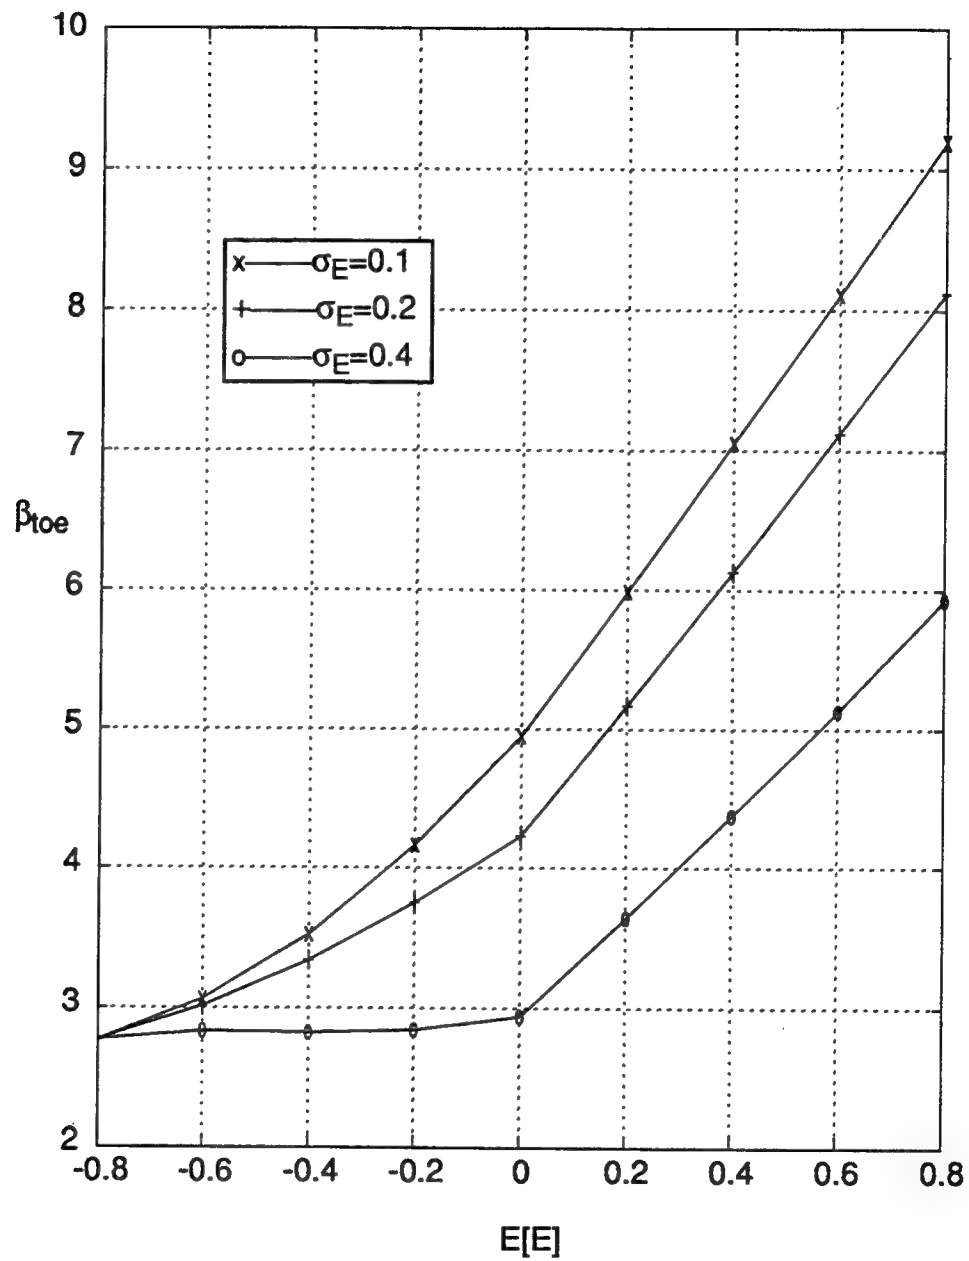
**Figure 7.4 Demopolis Locks and Dam, Monolith L-17, Resultant Location Analysis,  $\beta_{toe}$  versus  $E[E]$**

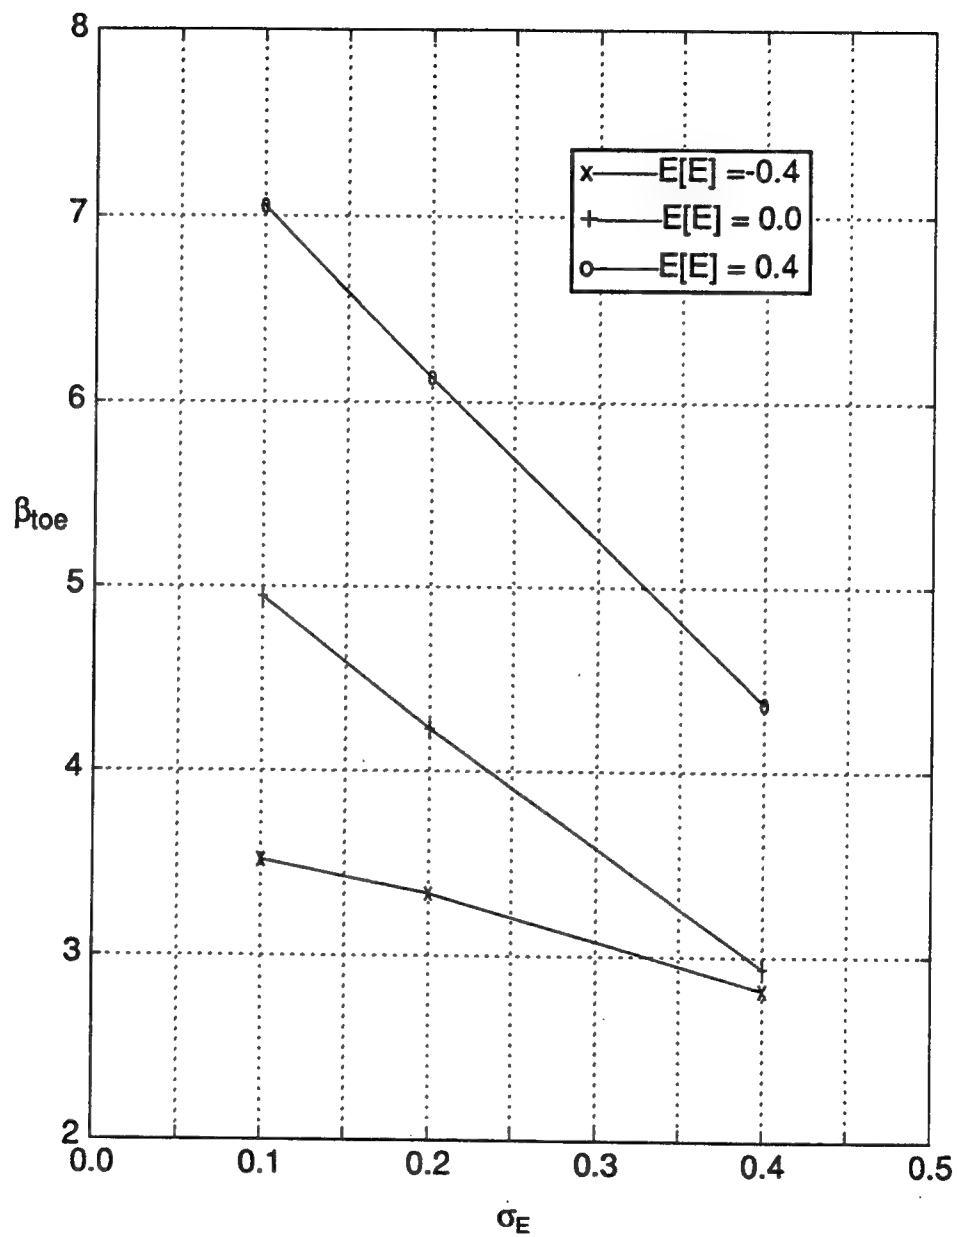
**Figure 7.5 Demopolis Locks and Dam, Monolith L-17, Resultant Location Analysis,  $\beta_{toe}$  versus  $\sigma_E$**

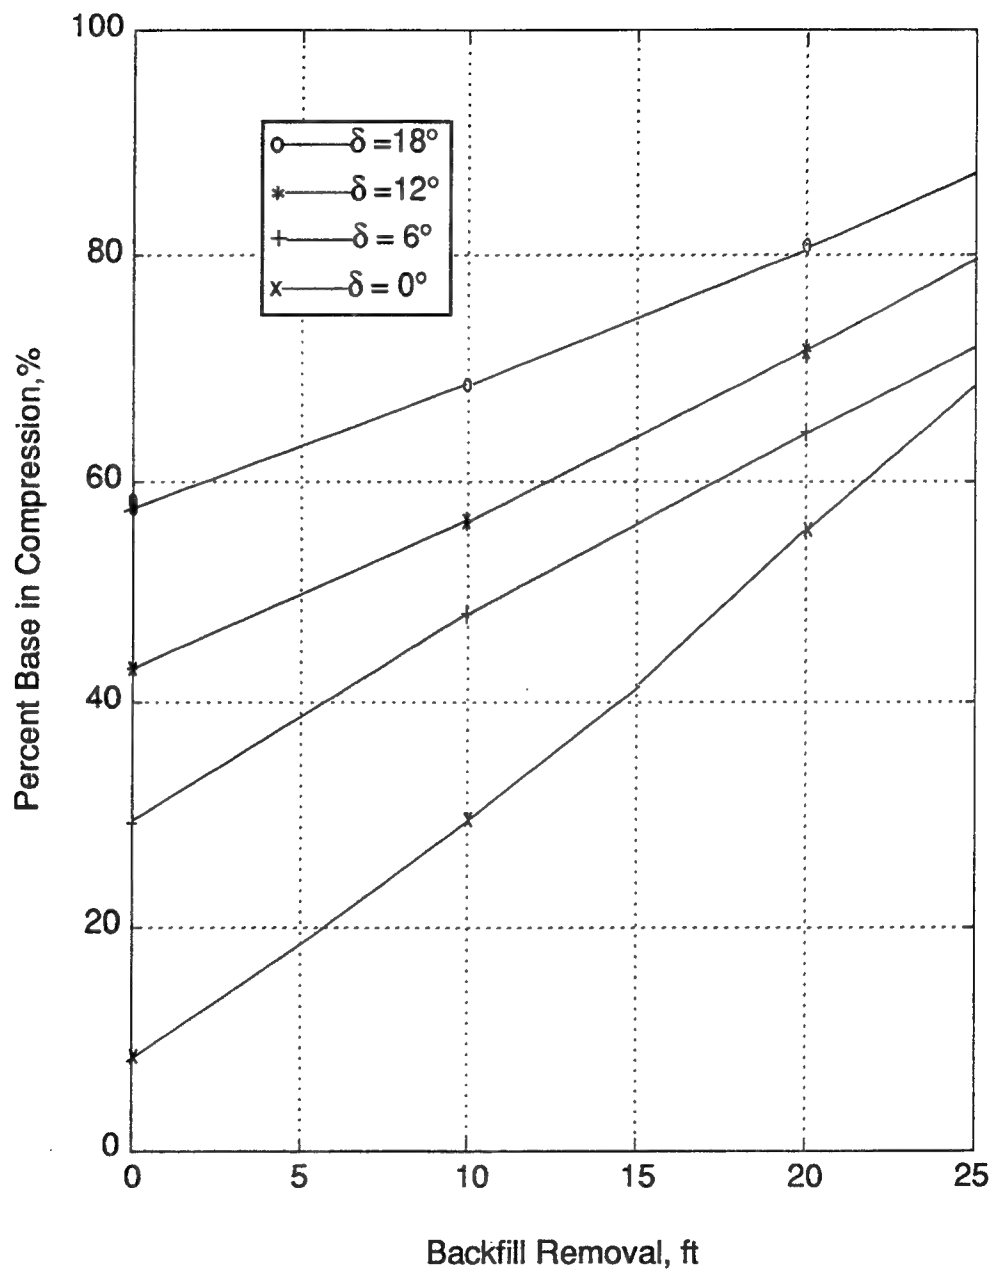
**Figure 7.6 Demopolis Locks and Dam, Monolith L-17, Resultant Location Analysis, Percent Base in Compression versus Backfill Removal**

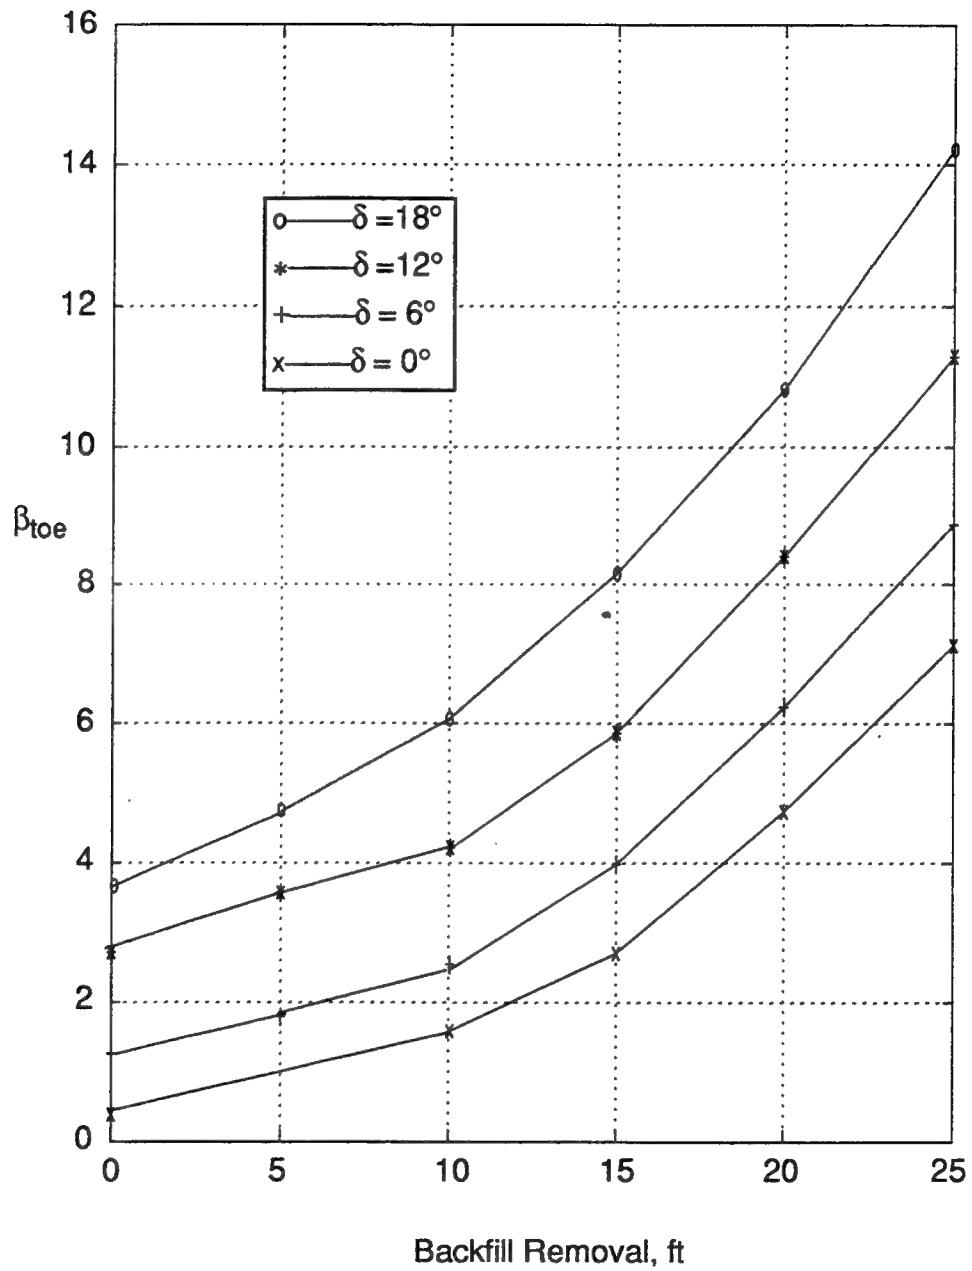
**Figure 7.7 Demopolis Locks and Dam, Monolith L-17, Resultant Location Analysis,  $\beta_{toe}$  versus Backfill Removal**

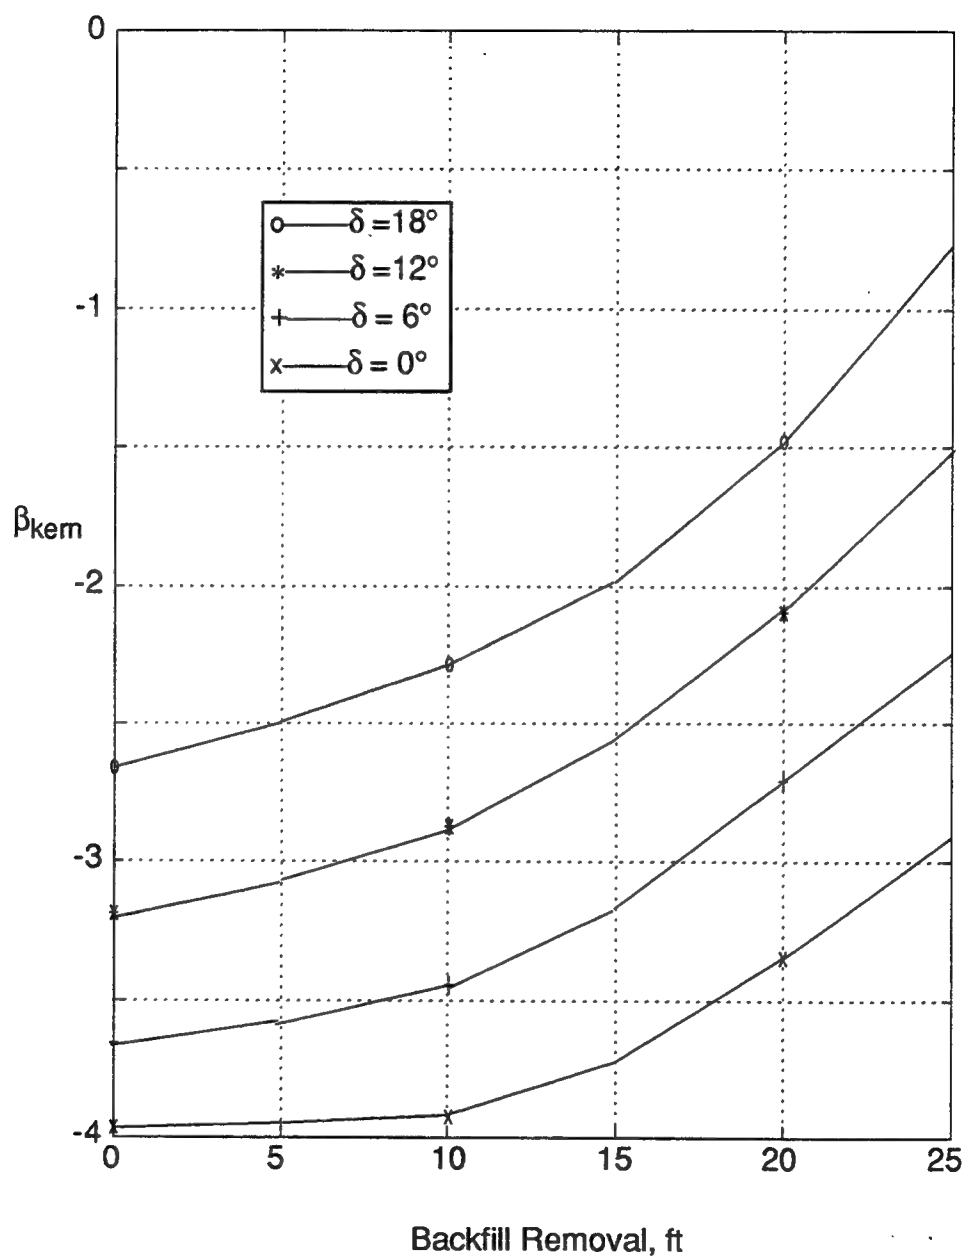
**Figure 7.8 Demopolis Locks and Dam, Monolith L-17, Resultant Location Analysis,  $\beta_{kern}$  versus Backfill Removal**

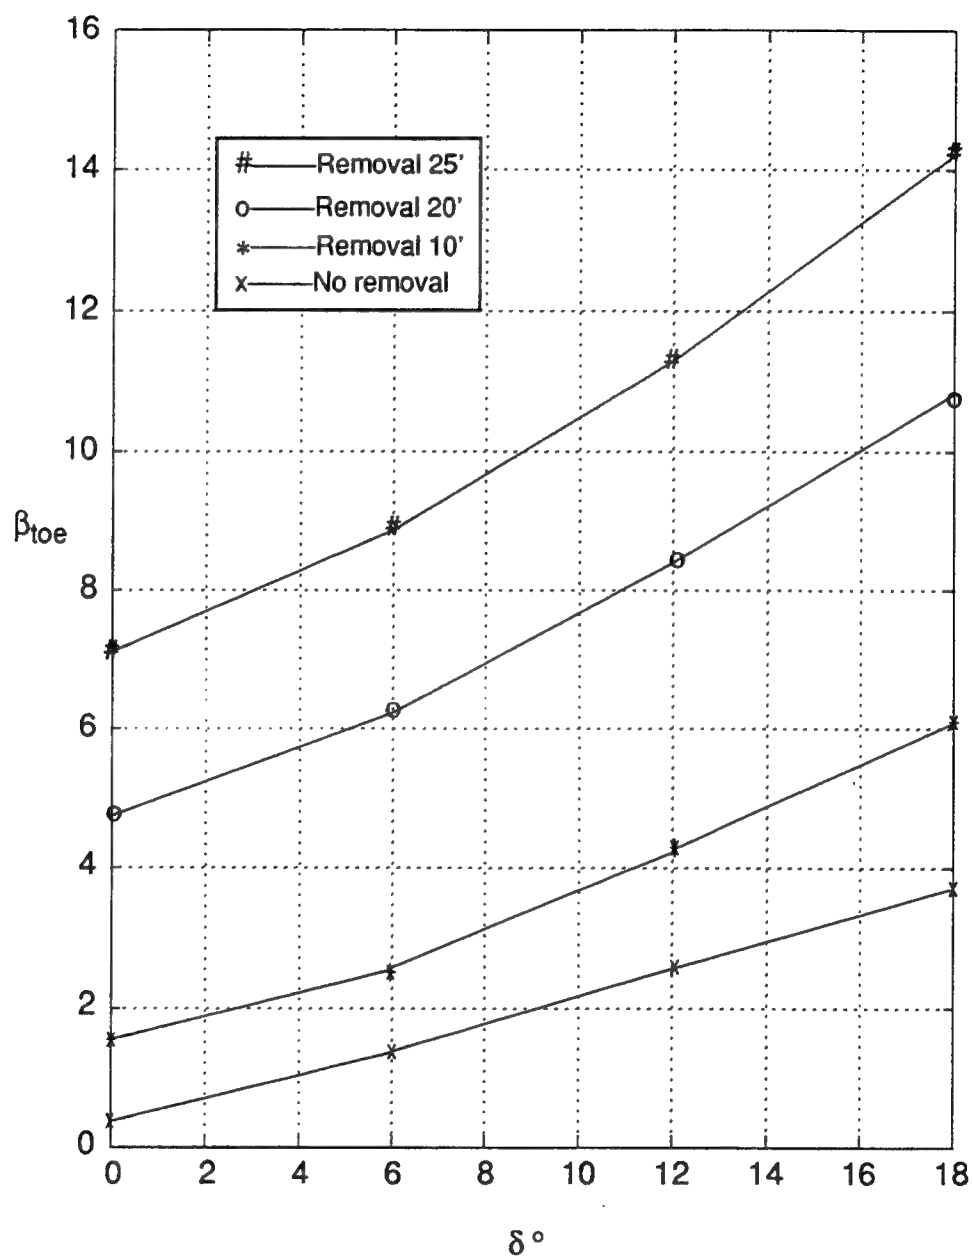
**Figure 7.9 Demopolis Locks and Dam, Monolith L-17, Resultant Location Analysis,  $\beta_{toe}$  versus Wall Friction Angle  $\delta$**

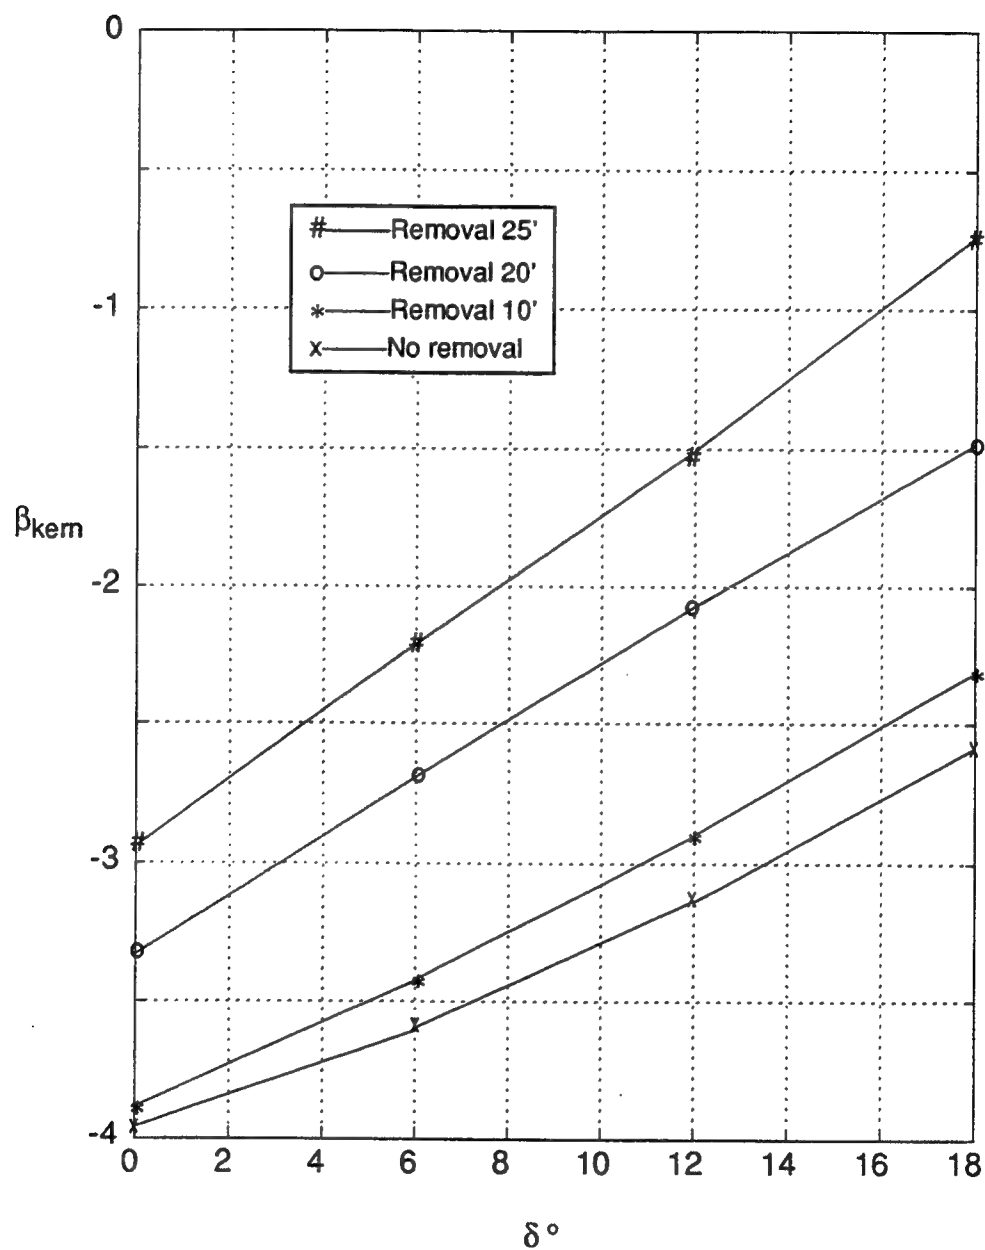
Figure 7.10 Demopolis Locks and Dam, Monolith L-17, Resultant Location Analysis,  $\beta_{kern}$  versus Wall Friction Angle  $\delta$
